The

Safety

Wire

September 2015

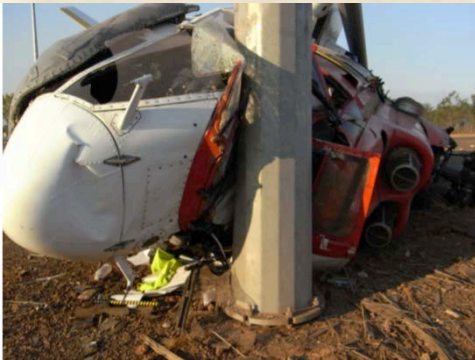
As the helicopter entered the parking area apron, the PIC was concerned about downwash from the main rotor affecting the forward aircraft. His focus was directed to maintaining adequate clearance from the aircraft wing tip on his right, while directing the copilot to ensure there was adequate clearance from a light pole to the left of the helicopter. The conversation between the pilots prior to the collision is reproduced below:

'Just check we are clear' - PIC.
'Yes' - copilot.
'Sure?' - PIC;
'yes' - copilot.
'Still clear?' - PIC;
'yes' - copilot.

Almost immediately there was a 'tick tick' sound then loud crunching sounds. The main rotor blades had struck the light pole (Figure 3) and started to break apart with debris flung about. The helicopter was rapidly propelled towards the light pole, toppling over onto its left side while vibrating vigorously and shedding blade debris in all directions.

This occurrence highlights that it can be difficult to assess the clearance of main rotors from obstacles through observation from the cockpit. Following the blade tip path may not provide sufficiently accurate guidance to the actual plane of rotation of the rotor disc due to the following:

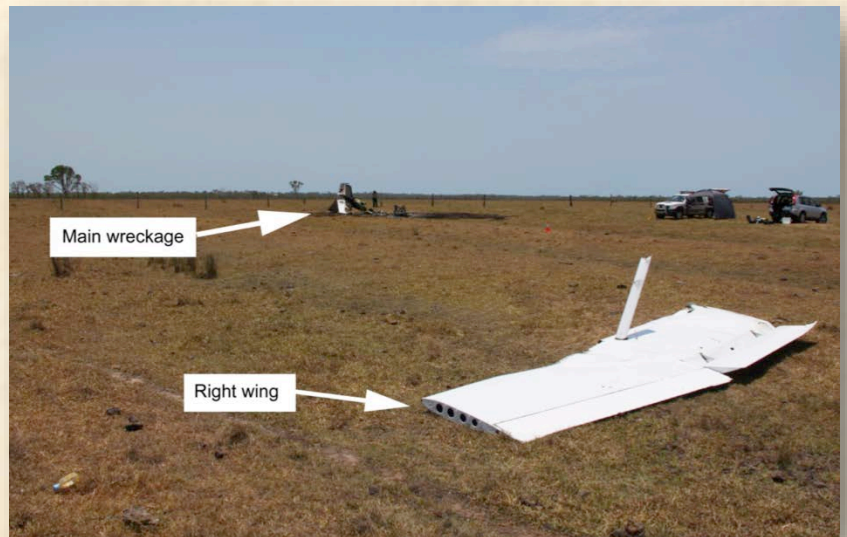
Figure 5 – Severed right wing strut

On 17 December 2012, a Cessna 182A impacted with electrical powerlines that ran alongside a parachute drop zone. The pilot was planning to attend a Christmas function at the drop zone and was flying to an airstrip located about 1.5 km to the north. After contacting the powerlines, the aircraft was seen to climb and continue to fly for approximately 500 m before the right wing separated from the aircraft. The aircraft subsequently impacted the ground and the pilot was fatally injured.

One witness located approximately 1 km north of the drop zone was able to describe the movements of the aircraft following the powerline impact. They reported the aircraft attempted to climb, turned slightly to the right, the right wing strut failed, immediately followed by both wings folding upwards, before one wing separated from the aircraft. The aircraft then nosedived behind trees.

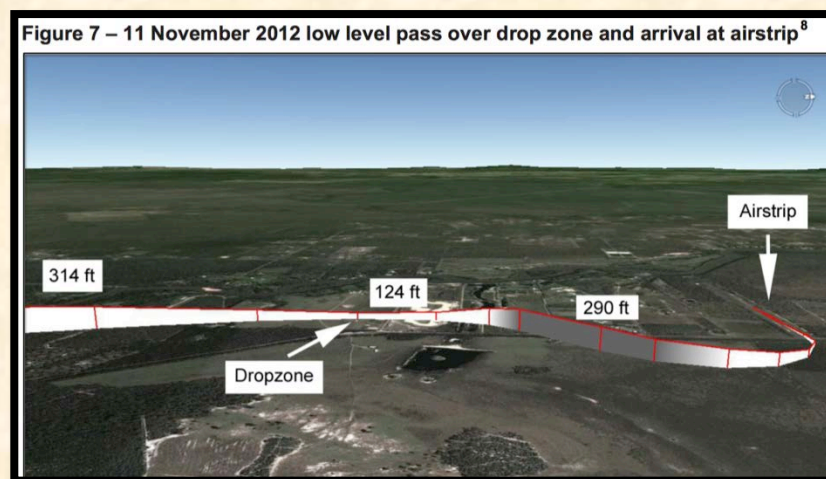
Accident investigations often reveal that the pilot was aware of the presence and location of a powerline and then subsequently flew into it. In this occurrence, the pilot had made parachute descents into the drop zone so it was probable that he was aware of the presence and location of the powerlines and the hazard posed to a parachutist landing at the drop zone.

[*Note the previous flights in the same area as the accident flight. It is likely that the pilot was aware of these wires]

A minimum height of 500 ft AGL for flight over non-populated areas is promulgated for very long-standing safety reasons. Pilots who choose to fly below this height without an operational reason to do so are exposing themselves, and any passengers that may be on board, to an increased risk of striking powerlines, many of which are difficult to see from the cockpit of an aircraft in flight. The circumstances of this accident highlight that risk.
