The

Safety

Wire

**April 2017**

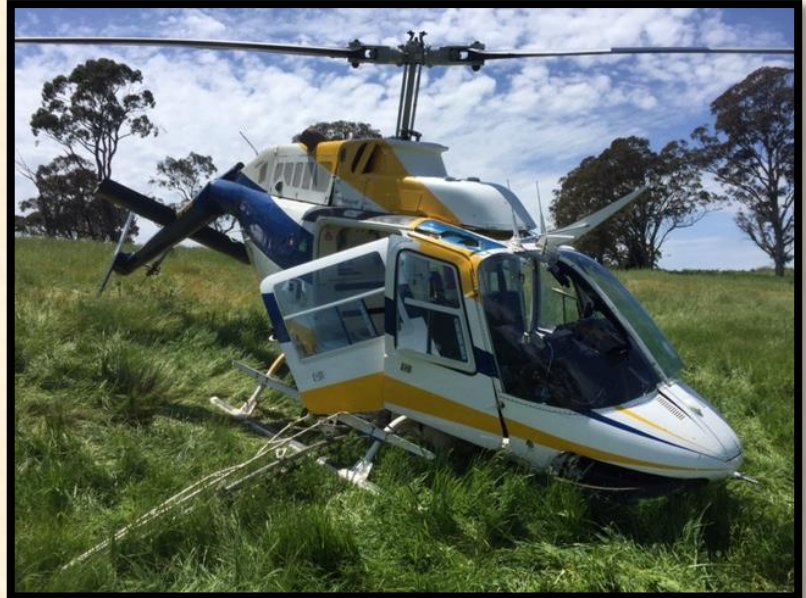
On 21 November 2016, at about 0730 Eastern Daylight-saving Time, a Bell 206B helicopter, registered VH-CHO, took off from a property about 30 km south of Bathurst, New South Wales. The pilot was conducting an aerial inspection of the property, with the farm manager on board as a passenger. At about 75ft above ground level and an airspeed of about 40kt, the pilot and passenger heard and felt a bang.

The pilot initially decided to land as soon as possible in order to check the helicopter to determine the cause of the bang, and started to slow it down. As the airspeed decreased, the helicopter started to yaw rapidly to the right and the pilot, unable to arrest the rotation with left anti-torque pedal, realized they had lost tail rotor authority. The pilot immediately rolled the throttle to the ground idle detent and as the helicopter stopped yawing, lowered the collective. The pilot saw that the rotor rpm had dropped to about 80 per cent and prepared for a hard landing. The pilot cushioned the landing by pulling back on the cyclic, but the helicopter landed heavily.

The pilot saw that the rotor rpm had dropped to about 80 per cent and prepared for a hard landing. The pilot cushioned the landing by pulling back on the cyclic, but the helicopter landed heavily.

The pilot and passenger sustained minor injuries and the helicopter was substantially damaged.

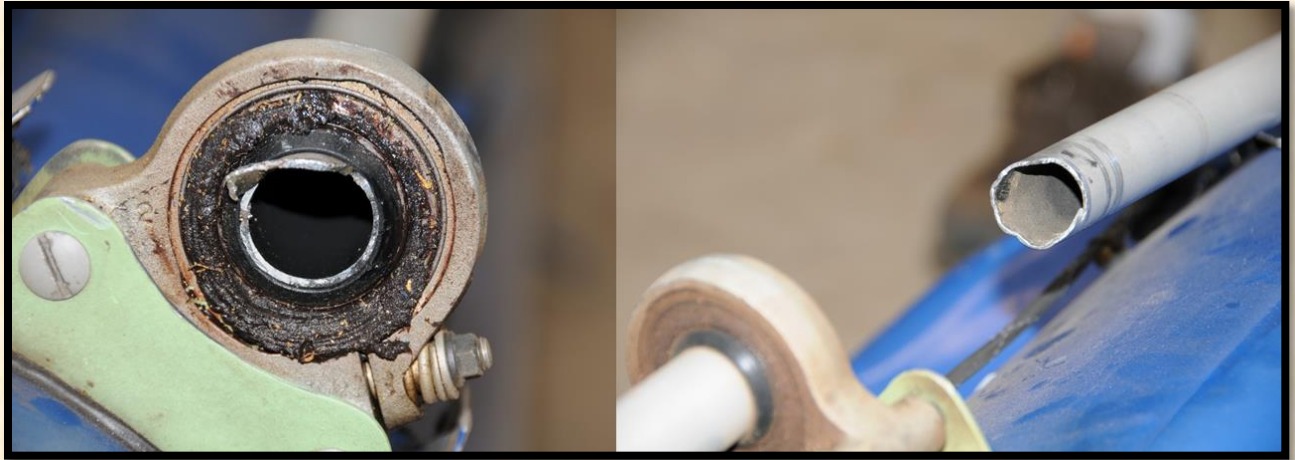
The helicopter had serial number 714, and was fitted with a long tail rotor driveshaft. The manufacturer required the single long driveshaft to be replaced with a segmented shaft in serial numbers 1252 and above. The tail rotor bearings were 'on condition' items, that is, were required to be replaced if worn on inspection. The driveshaft was inspected every 1,200 hours and was in good condition apart from the fracture after the accident. On 18 August 2016, the No. 1 and No. 3 tail rotor driveshaft bearings and tail rotor gearbox were replaced. On 29 September 2016, the No. 1 tail rotor bearing and bearing hanger were replaced. Post-accident inspection did not reveal any abnormalities.
