The

Safety

Wire

August 2023

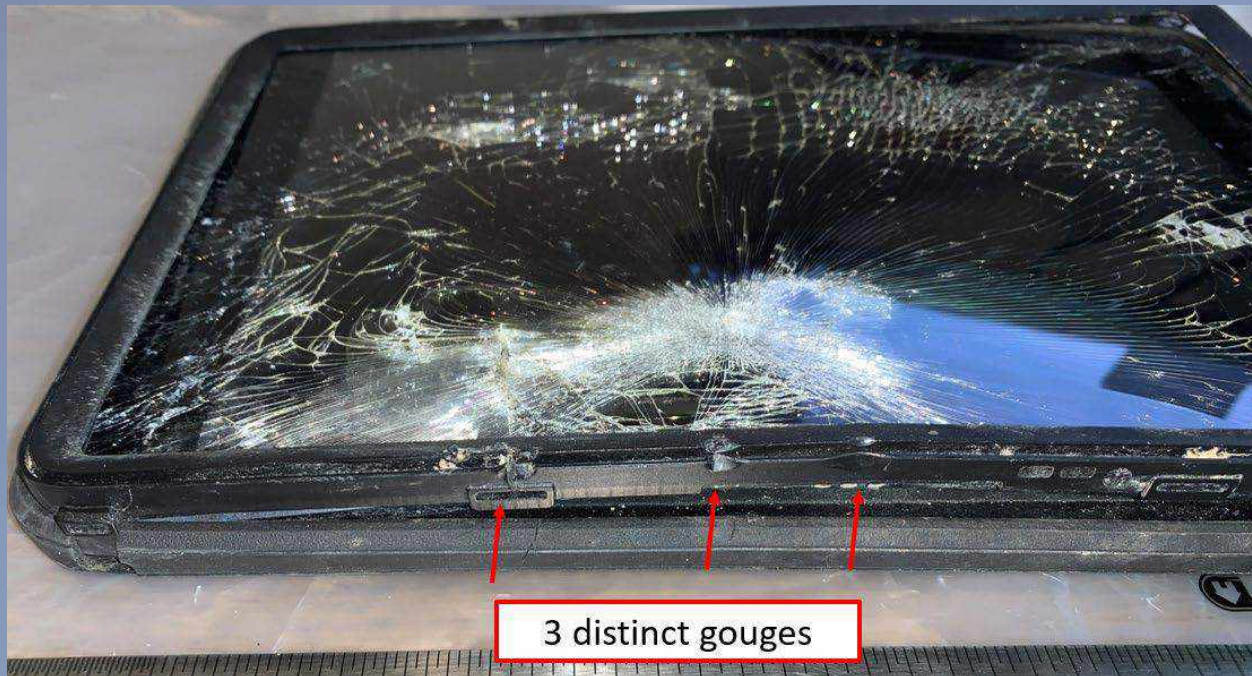
During recovery of the accident helicopter, the flight crew's Apple iPad was found in the river near the cockpit. Figure 1 shows the overall damage to the iPad as recovered. There were three distinct gouge marks on the left side of the iPad and its case, when viewed in portrait mode. The iPad exhibited a bend from the back of the case toward the screen. The top two gouges extend from the edge of the case inward into the screen about 3 inches. The bottom gouge is shallower and does not extend into the screen.

Figure 1. Condition of iPad after the accident with 3 distinct gouges in the iPad and it's case. The gouges are on the left side of the iPad when viewed in portrait mode. In the image, the iPad is rotated left into landscape mode.

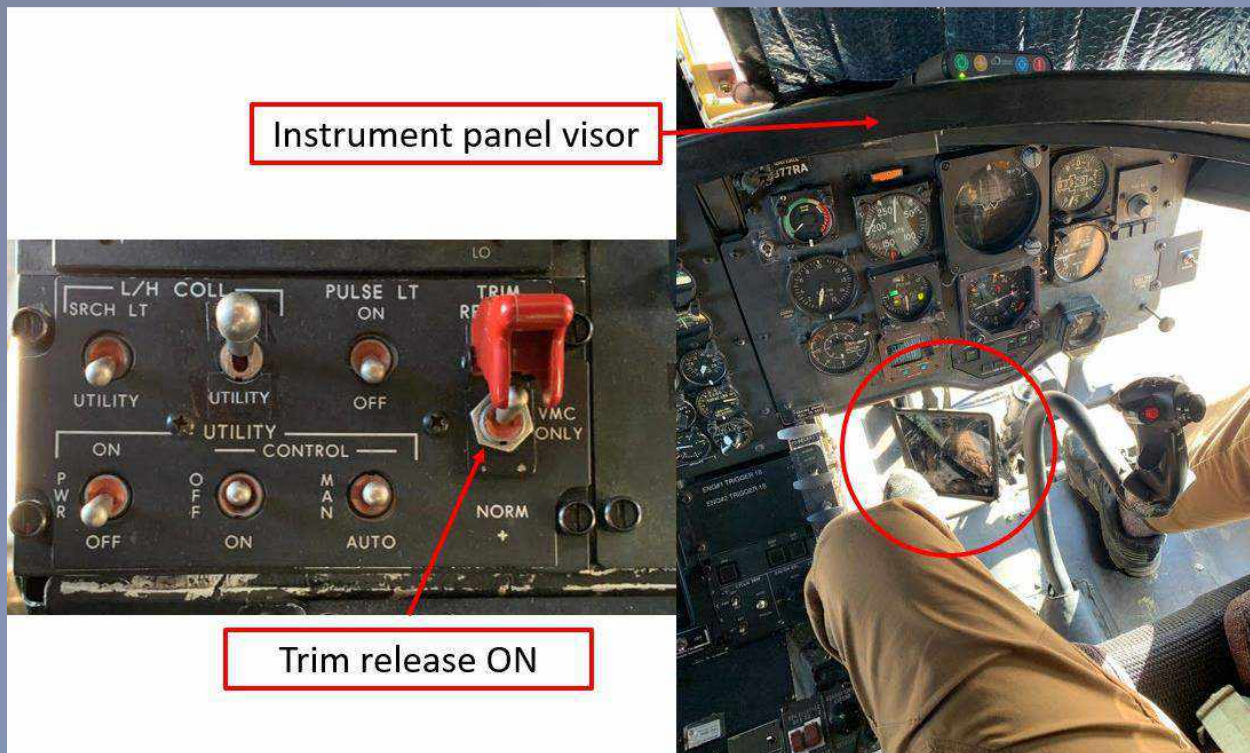
Figure 2. Trim release ON and iPad placed in co-pilot's left pedal area.

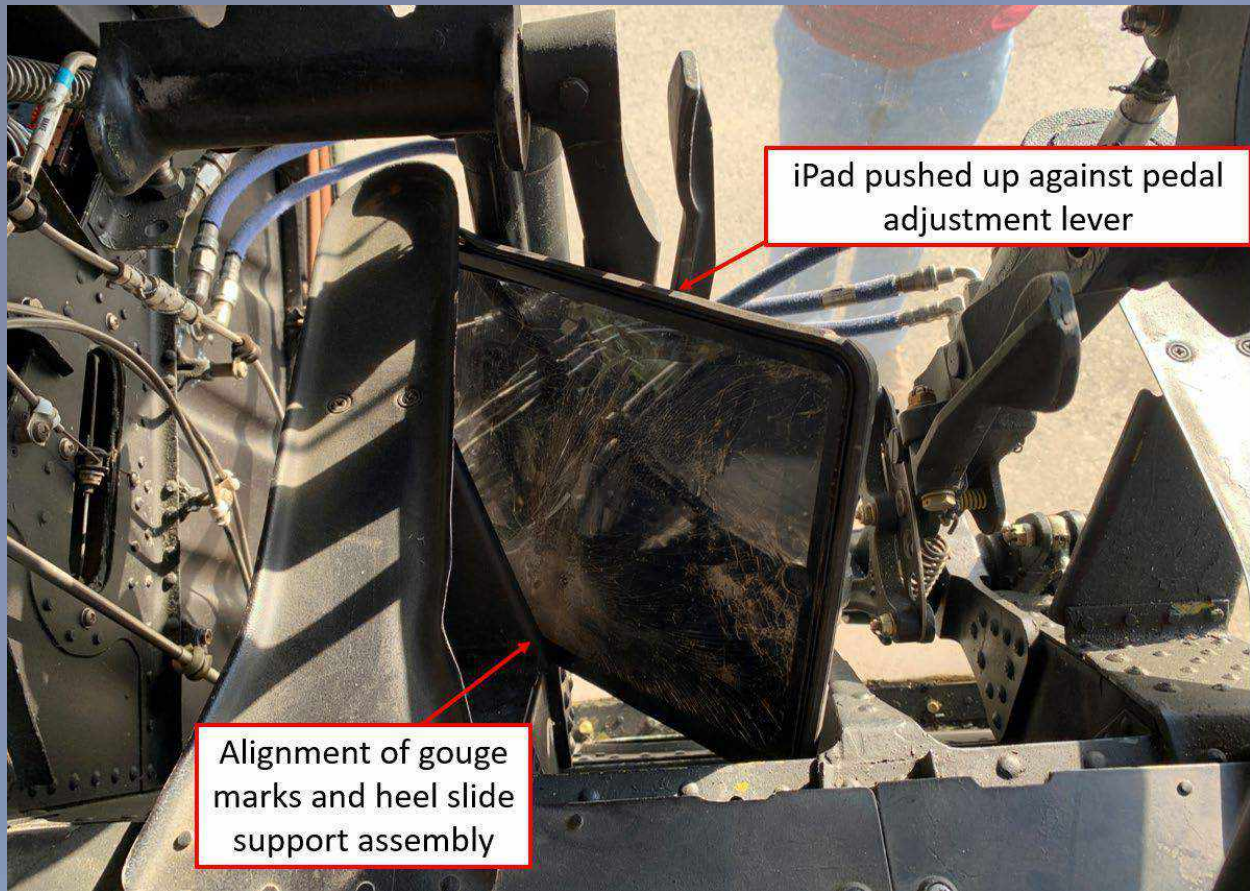
When pressure was applied to the pilot's right pedal, the iPad was squeezed in between the pedal and the heel slide support assembly, which was concentrated near the gouges. The gouges in the iPad aligned with a sharp, vertical metal piece of the heel slide support assembly underneath the heel slide, as seen in Figures 3, 4, and 5. Additional right pedal input forced the iPad to apply more pressure to the co-pilots pedal adjustment lever.

iPad pushed up against pedal adjustment lever

Alignment of gouge marks and heel slide support assembly

Figure 3. The iPad impinged in between the co-pilot's left pedal and the airframe. The back side of the iPad is pushing against the left pedal adjustment lever. The lower left corner of the iPad is lodged into a small corner of the airframe. The gouges in the iPad aligned with a sharp, vertical metal piece of the heel slide support assembly.

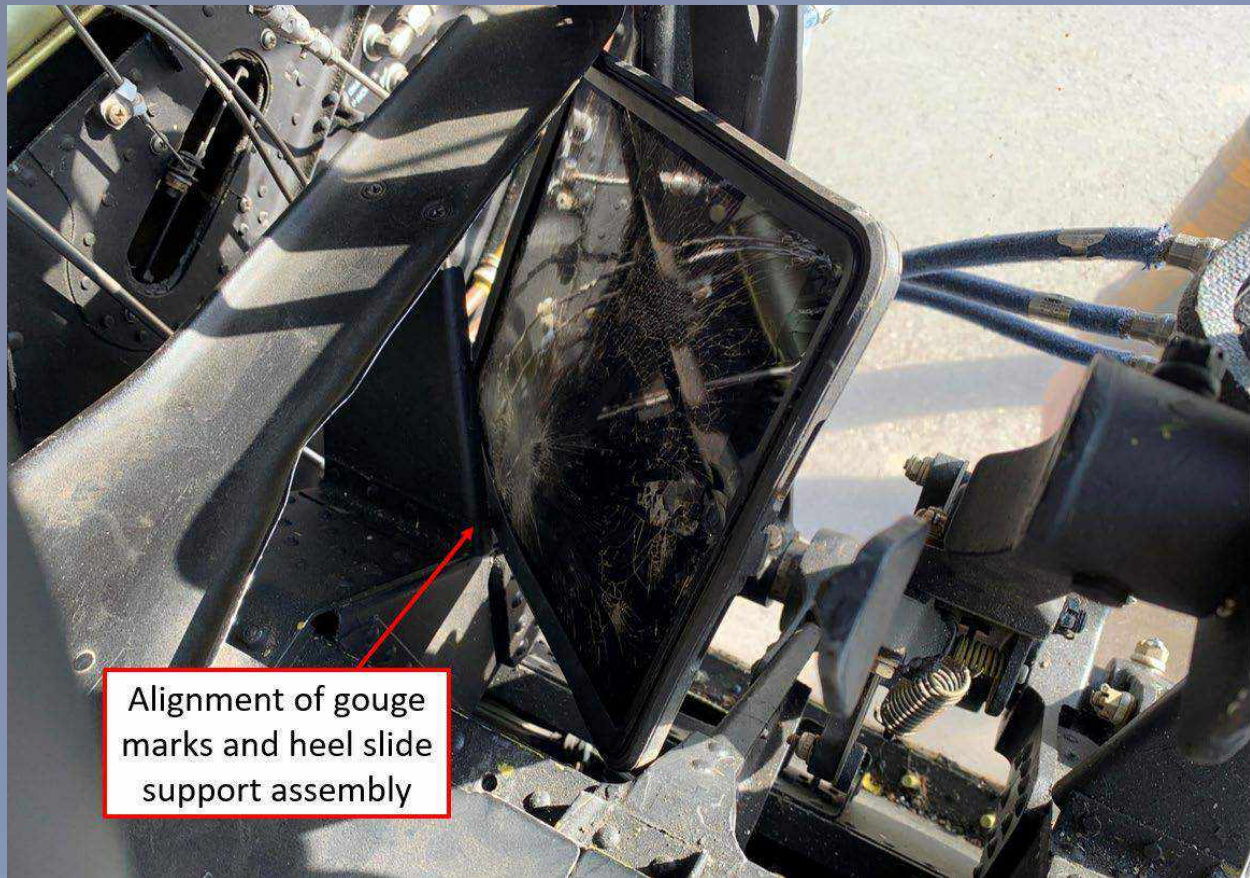
Once the iPad was placed in the co-pilot's left pedal area, the pilot's pedals were slowly manipulated to determine how the position of the iPad would change. Additional pressure was applied to the pilot's left pedal, which allowed the iPad to fall farther into the left pedal and jam between the heel slide support assembly. The jammed iPad prevented the pedals from recentering. The iPad also pushed against co-pilot's left pedal adjustment lever.

Figure 4. The iPad impinged in between the co-pilot's left pedal and the airframe. The lower left corner of the iPad is lodged into a small corner of the airframe. The gouges in the iPad aligned with a sharp, vertical metal piece of the heel slide support assembly.

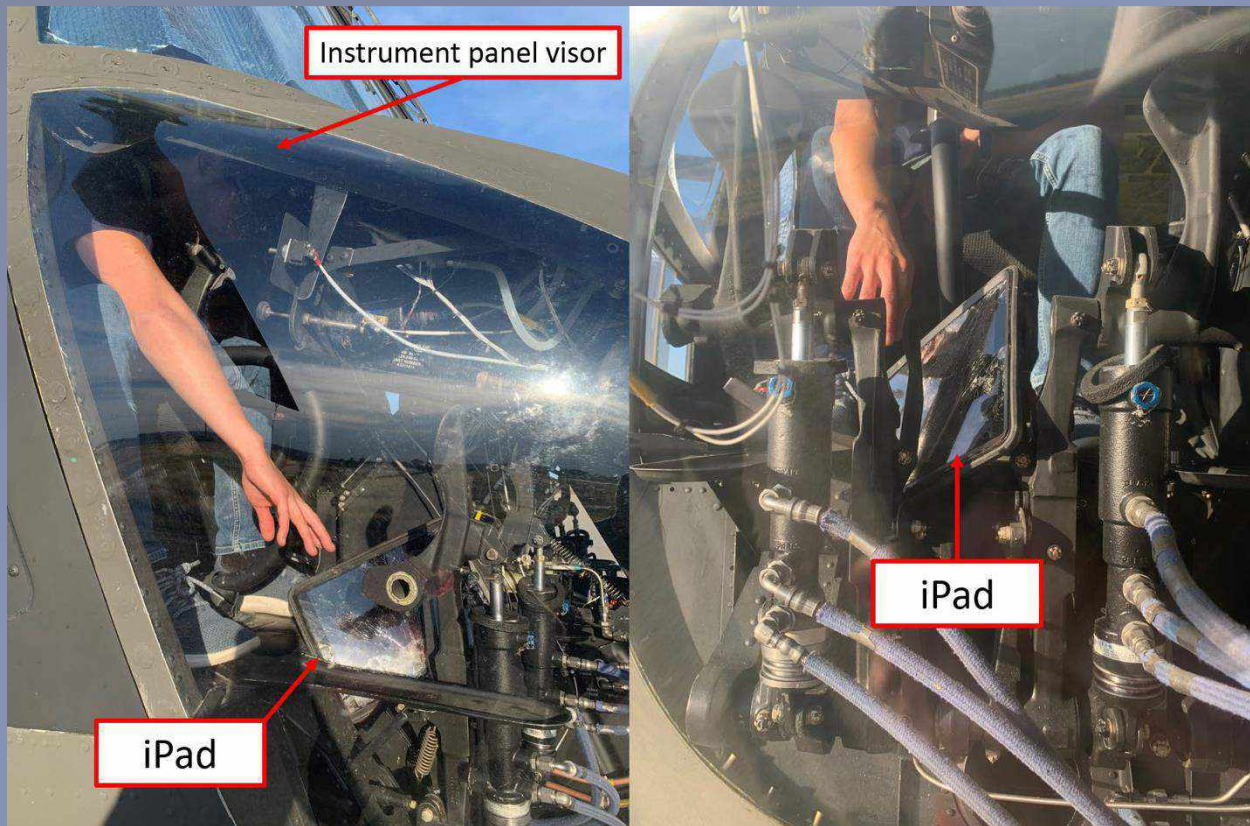
With the seat restraints on and seats adjusted for comfort, both a 5'7" male and 6'2" male could not reach the iPad in this position. The accident co-pilot's height was 5'10". Additionally, wearing a flight helmet would limit the ability to reach down as the flight helmet would contact the instrument panel visor as seen in Figure 5.

Figure 5. Exemplar 5'7" male wearing seat restraints is reaching for the iPad. The restraints and instrument panel visor prevent the iPad from being accessible.
