**The**

**Safety**

**Wire**

## NTSB Urges FAA to Require Immediate Inspection of Bell 407 Tail Boom Attachment Hardware and Fittings

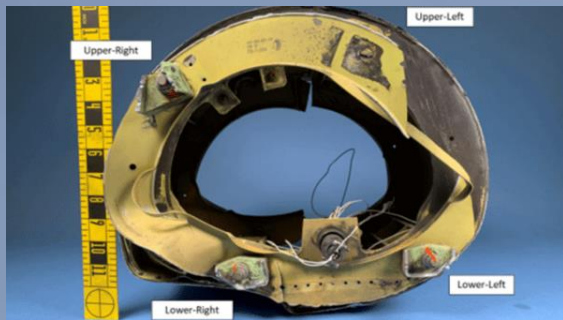
The examination of the accident site revealed the tail boom came to rest about 762 ft northeast from the main wreckage, consistent with an inflight separation. Examination of the tail boom revealed it separated from the fuselage at the tail boom

attach point. Figure 1 shows the location of separation and the attachment fittings and hardware used to secure the tail boom to the fuselage.

The upper-left tail boom attachment hardware, consisting of a bolt, washers, and a nut, was not present at the accident site and was not found. The attachment fitting remained connected to the fuselage. Damage to the upper-left attachment bolt holes indicates the bolt had been installed at some point before the accident flight; it is unknown at this time when or why the bolt separated. Additionally, the lower-left, lower-right, and upper-right tail boom attachment fittings (connecting the tail boom to the aft fuselage) were fractured and found, along with their attachment hardware, with the tail boom wreckage. The lower-left fitting had multiple fatigue fractures, while the upper-right and lower-right attachment fittings had overload fractures. The initiation of fatigue cracks on the lower-left fitting indicates that the tail boom did not immediately separate from the helicopter upon the separation of the upper-left attachment hardware.

According to Bell (the helicopter manufacturer), the upper-left tail boom attachment fitting has the highest tension loading of the four attachment fittings and is considered the most important of the four attachment fittings between the tail boom and the aft fuselage. The upper-left tail boom attachment bolt separated first, resulting in the redistribution of the load normally carried by the upper-left attachment fitting to the remaining three attachment fittings and the subsequent initiation of fatigue fractures on the lower-left attachment fitting. Based on preliminary analysis of the fatigue crack growth on the lower-left attachment fitting, it is possible that the fatigue crack grew over multiple takeoffs and landings. However, this analysis is ongoing, and the results of the analysis, once completed, will be shared with the FAA and the Transportation Safety Board of Canada.

Require operators of Bell 407 helicopters to conduct an immediate torque check of the tail boom attachment hardware, as well as a visual inspection of the tail boom attachment fittings for evidence of cracks and fractures, and report findings to the FAA. (A-22-28) (Urgent)

Require operators of Bell 407 helicopters to conduct subsequent torque checks of the tail boom attachment hardware and visual inspection of the tail boom attachment fittings as referenced in Safety Recommendation A-22-28 at an interval significantly less than the currently required interval to provide multiple opportunities for detecting any improperly

installed or fractured attachment hardware or fittings. Require operators to report findings to the FAA. (A-22-29) (Urgent)

Require operators of Bell 407 helicopters to conduct an immediate torque check of the tail boom attachment hardware, as well as a visual inspection of the tail boom attachment fittings for evidence of cracks and fractures, and report findings to Transport Canada. (A-22-30) (Urgent)

Require operators of Bell 407 helicopters to conduct subsequent torque checks of the tail boom attachment hardware and visual inspection of the tail boom attachment fittings as referenced in Safety Recommendation A-22-30 at an interval significantly less than the currently required interval to provide multiple opportunities for detecting any improperly installed or fractured attachment hardware or fittings. Require operators to report findings to their respective regulatory authority. (A-22-31) (Urgent)
