The

Safety

Wire

January 2022

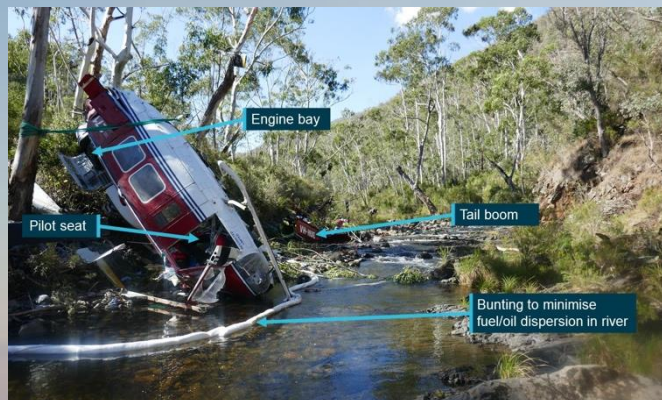
On 17 April 2018, the pilot of a UH-1H was conducting long-line lifting operations. While on approach to pick-up a load, the helicopter's engine failed. During the subsequent forced landing, the helicopter collided with trees and a riverbed. The pilot sustained serious injuries and the helicopter was destroyed.

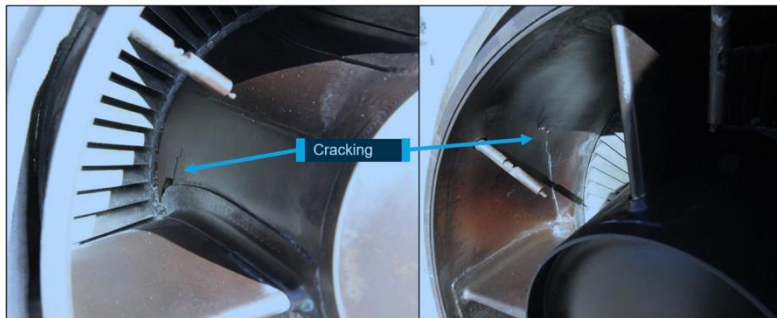
Figure 7: Visible cracking in the exhaust diffuser area

The ATSB found that the inner struts in the exhaust diffuser fractured leading to the engine failure. The fracture was the result of high-cycle metal fatigue, which had not been detected for at least 36 routine maintenance inspections prior to the accident. It
